# Renaturalization Drives Hydromorphological Recovery in Degraded Gravel-Bed Streams in Poland

Paweł Mikuś

Institute of Nature Conservation, Polish Academy of Sciences, Al. A. Mickiewicza 33, 31-120 Kraków, Poland; mikus@iop.krakow.pl

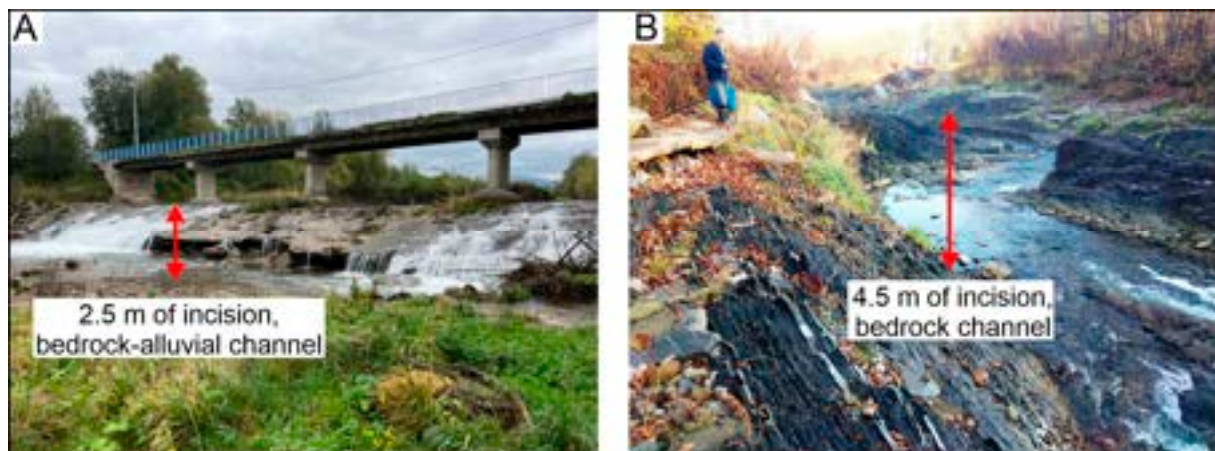
**Figure 1.** Effects of rapid channel incision of rivers in Southern Poland illustrated on the Czarny Dunajec river (A) and Krzyworzeka Stream (B).

Undoubtedly, the most dangerous phenomenon is river incision, which has been observed in every Carpathian watercourse and ranges from 1.0 to nearly 4.0 m [11]. This process continues to occur today and, in addition to the previously mentioned effects, it causes headward and lateral erosion (posing a threat to hydraulic structures), destruction of the hyporheic zone (which functions within the gravel riverbed), and the lowering of the surface water table (Figure 1).

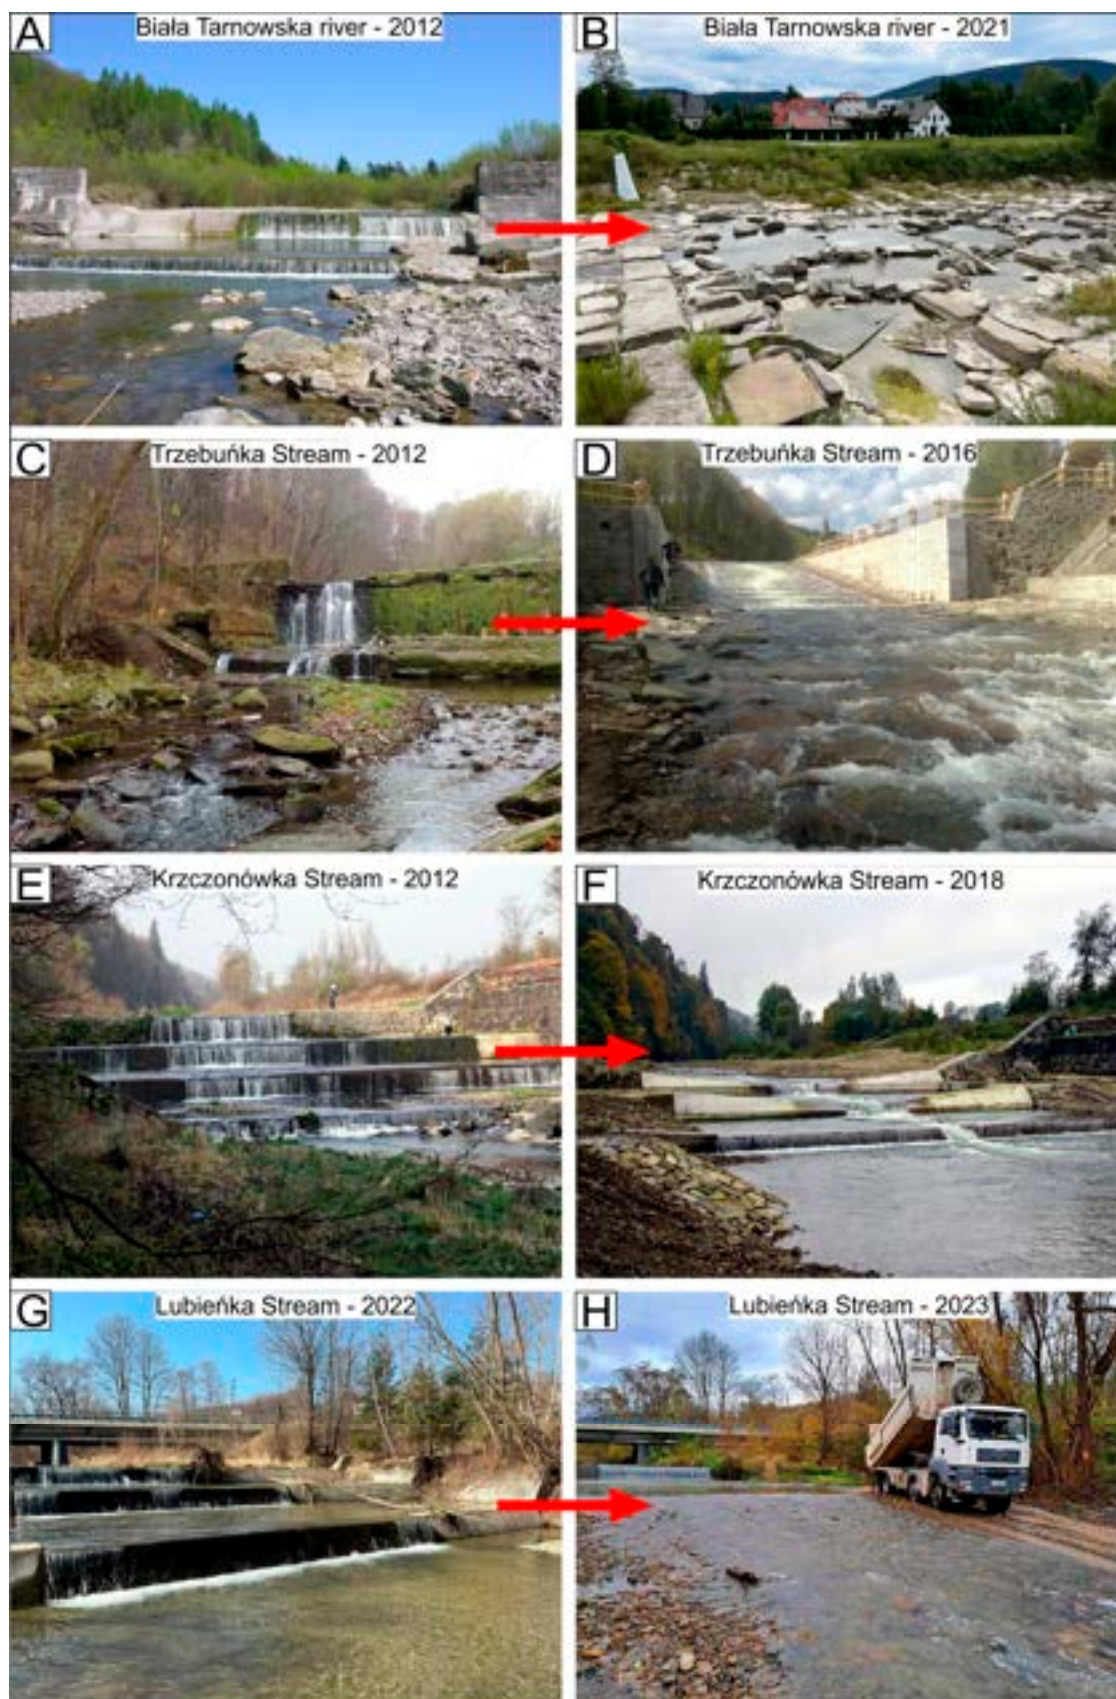
**Figure 7.** Concrete weir on the Biała Tarnowska river (A) rebuilt into a “honeycomb” type riffle (B); reconstruction of a high check dam on Trzebuńka Stream (C) into a long-roughened riffle serving also as a fish pass (D); and filling of old weirs on the Krzczonówka (E,F) and Lubieńka (G,H) streams with a gravel.

Figure 6 presents an example application of artificial riffles designed to mitigate the harmful impact of old concrete weirs on the Krzyworzeka Stream (Figure 2, number 17). With relatively little effort, exclusively within the framework of maintenance works, it is possible to restore the longitudinal continuity of the stream. An additional advantage is “river feeding” with much-needed and scarce rock–alluvial material in the form of a mixture from local gravel pits and quarries. Sediment replenishment is used not only in large rivers impounded by dams, where the downstream channel is sediment starved, but such measures are also undertaken locally in small mountain and upland streams that have either become excessively incised or contain bed material that is too fine—neither in dynamic equilibrium with current channel parameters nor suitable as spawning habitat for fish. A field example of successfully completed work using this technique is the filling of concrete thresholds on the Krzczonówka and Lubieńka streams with appropriately granulated and compacted gravel (Figure 7E–H).

- Trzeburka Stream, blocked by high check dam since 1935, was subjected to restoration within the project “The Upper Raba river spawning grounds” (Figure 7C,D). An 8 m-high dam was replaced with a 95 m-long structure, 65 m of which were built using so-called “grouted rock,” designed to resemble a natural rocky riverbed. The final design ensures full accessibility for people and all animal species, allowing unhindered migration along the stream. The structure can convey floodwaters and transport bedload, and its channel is dimensioned to accommodate very low, low, average, and high flows. During each of these flow conditions, the structure appears as though it were specifically designed for that state. It meets the requirements for stability, flood control, environmental compatibility, and enhanced amenity value.
