Changes of fluvial processes caused by the restoration of an incised mountain stream

Channel incision
Stream restoration
Block ramp
Hydraulic modelling
Floodwater retention
Hydromorphological quality

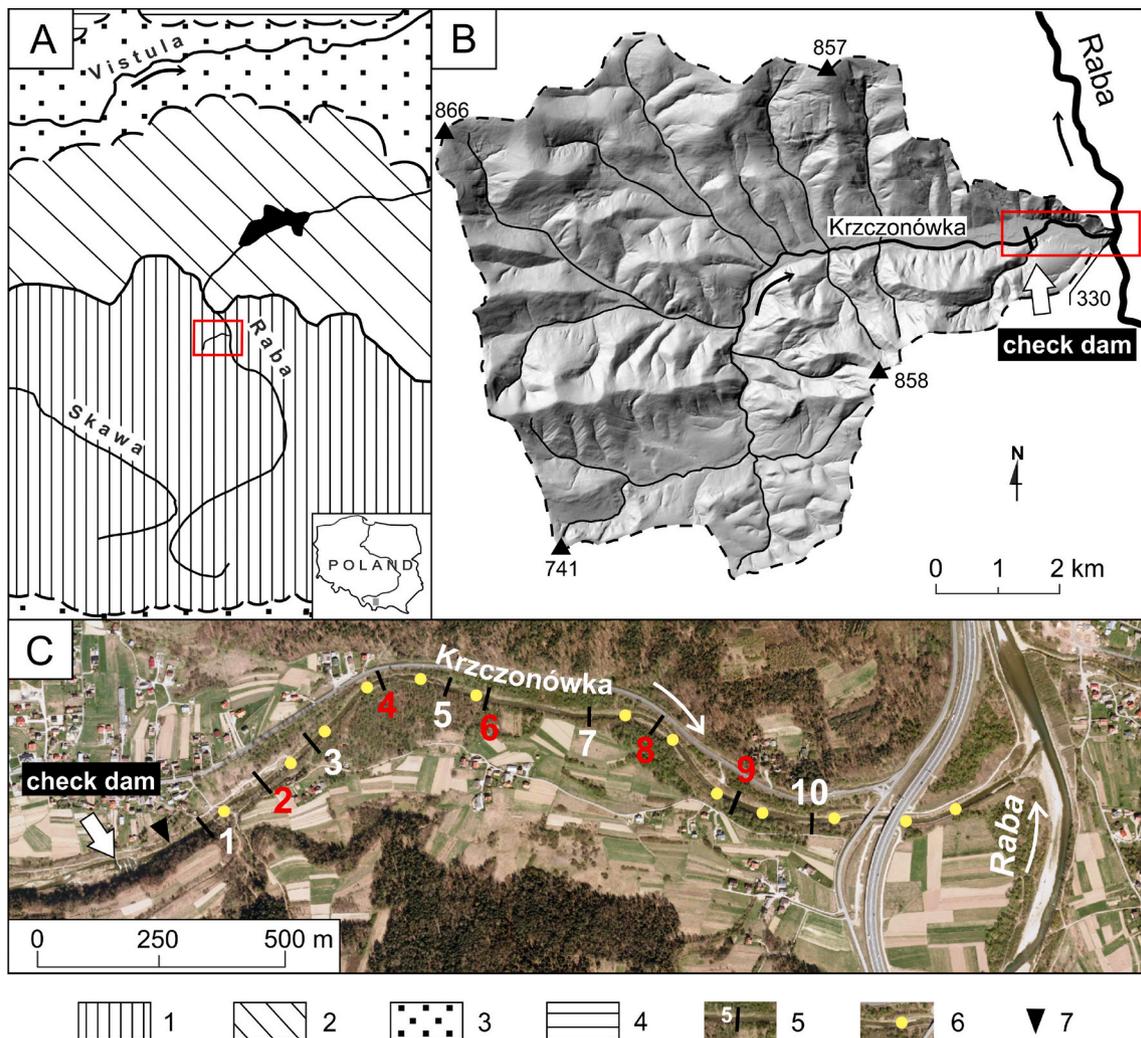
Fig. 1. (A) Location of Krzczonówka Stream in relation to physiographic regions of southern Poland. (B) Krzczonówka Stream catchment. (C) Orthophoto from 2009 showing the studied stream reach and the location of surveyed cross-sections and block ramps formed in 2013. 1 – mountains of intermediate and low height; 2 – foothills; 3 – intramontane and submontane basins; 4 – uplands; 5 – surveyed stream cross-sections; 6 – block ramps; 7 – water-gauge station. Red numbers denote the cross-sections for which the assessment of hydromorphological stream quality was performed. (For interpretation of the references to colour in this figure legend, the reader is referred to the web version of this article.)

Krzczonówka Stream is a left-bank tributary of the Raba River in the Polish part of the Western Carpathians (Fig. 1). It has a length of ca. 17 km and drains a catchment 92.9 km² in area. The catchment has low-mountain relief, with the highest point located at an elevation of 867 m a.s.l. and the stream mouth to the Raba River at 330 m a.s.l. (Fig. 1B). It is underlain by flysch complexes of the Magura Nappe composed of sandstones and shales with a subordinate occurrence of marls and conglomerates.

The study was conducted in the 2-km-long, lowest reach of the stream located downstream of a 3.7-m-high, closed check dam (Fig. 1C). The check dam was built in the years 1935–1951 and its construction caused long-term sediment starvation of the downstream reach. A map of the Third Military Survey of Austro–Hungary indicates that in the late nineteenth century the stream in the lowest reach flowed in a wide, multi-thread channel. In the early 1960s the channel was still wide, but single-thread (Lenar-Matyas et al., 2015). Channelization works comprising training of the stream with numerous groynes and lining of concave banks with gabions and rip-rap started in the late 1950s and since then they have caused up to a threefold narrowing of the active channel (Lenar-Matyas et al., 2015). Both sediment starvation and channelization of the stream induced up to 2 m of channel incision and transformation of the alluvial bed into a bedrock–alluvial or bedrock bed. As a result, in 2012 the channel was relatively deep (Fig. 2A) and bedrock exposures occurred on ca. 50% of the reach length, especially close to the check dam (Fig. 3A).

thalweg inflection points, like natural riffles. Only in the middle part of the reach, the lack of access for heavy machinery prevented installation of ramps, and here the distance between the neighbouring ramps was 325 m (Fig. 1C). The ramps on their downstream side had a slope a few times steeper than the average channel slope. Moreover, they were concave in cross-section in order to concentrate flow in the middle of the channel (Fig. 2C).

In 2012, at the beginning of the restoration project, 10 study cross-sections were delimited in the stream reach downstream from the check dam (Fig. 1C). They were located to run across pools at the half-distance between the planned block ramps, and they remained in the

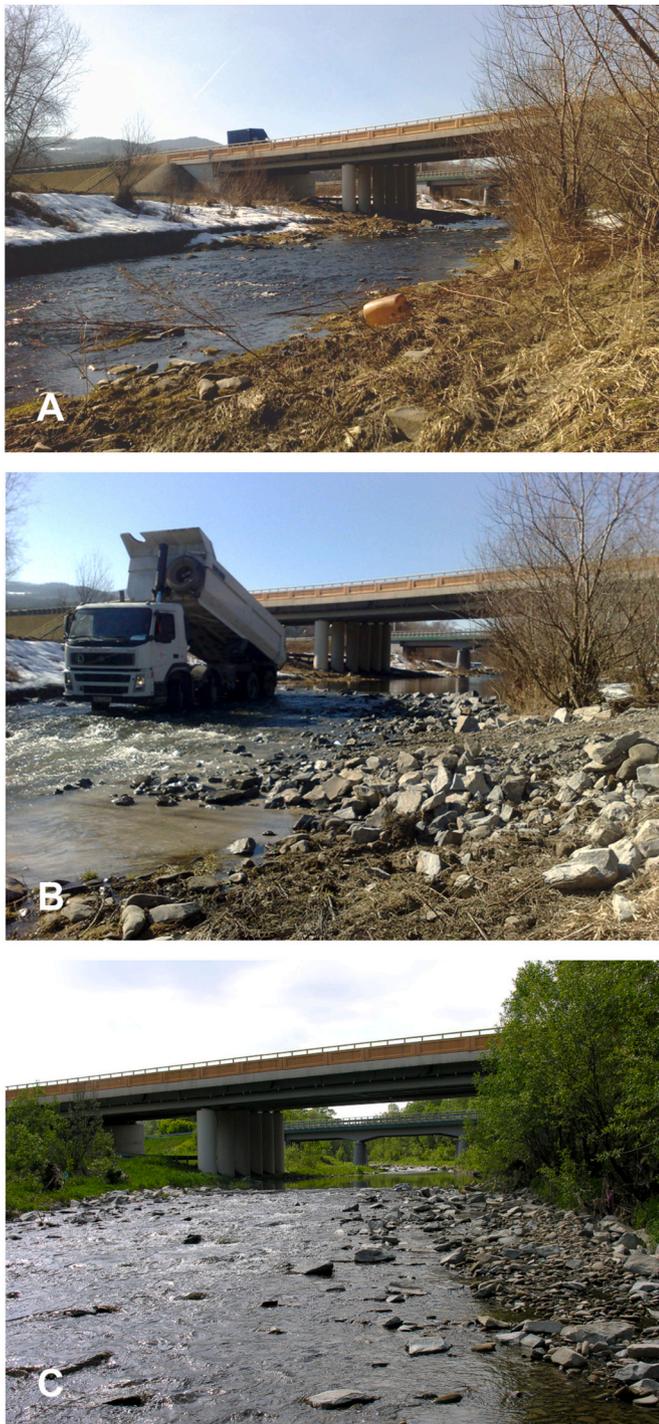
Fig. 2. (A) View of the Krzczonówka channel shortly before the installation of block ramps. (B) Works to install a block ramp in Krzczonówka Stream in March 2013. (C) View of the block ramp during low flow in May 2013. Visible considerably steeper water slope on the ramp than upstream of it and parabolic cross-section of the ramp causing concentration of flow in the middle of the channel.

The block ramps were constructed in March 2013 (Fig. 2B) of rock rubble from a nearby quarry with a topping of coarse gravel compacted by a road roller. They were spaced about 120 m apart and located at

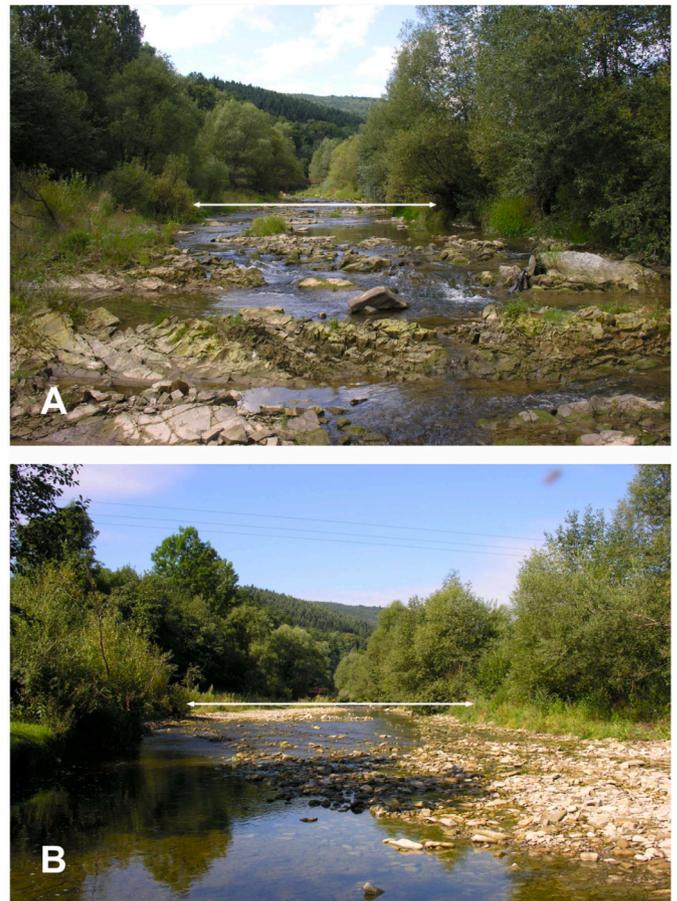
Fig. 3. View of Krzczonówka Stream in the vicinity of cross-section 2 in 2012, before installation of block ramps (A), and after the passage of the flood of 2014 (B). Visible change from bedrock to alluvial boundary conditions as a result of gravel deposition in the channel.

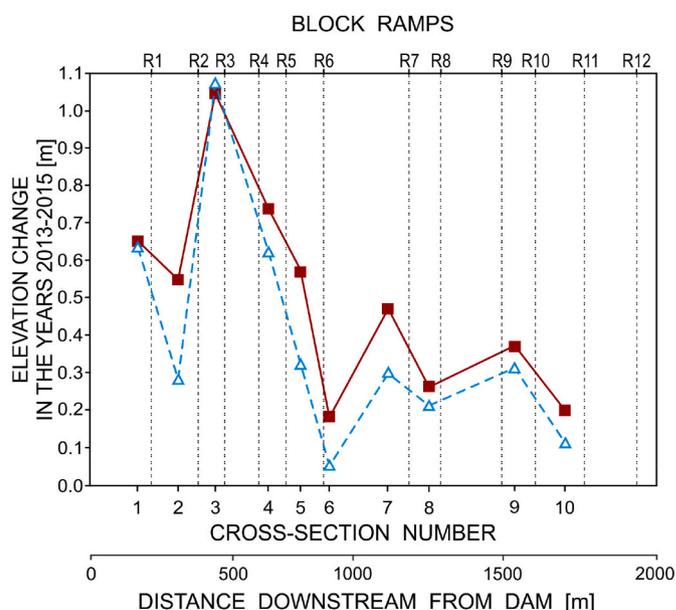
Fig. 4. Changes in mean elevation of channel bed (solid squares and solid line) and in the elevation of low-flow water surface (empty triangles and dashed line) in 10 study cross-sections of Krzczonówka Stream between 2013 and 2015. The location of block ramps along the stream reach downstream from the lowered check dam is also shown.

On average, sediment deposition increased mean elevation of the channel bed in 10 study cross-sections by 0.50 m and that of low-flow water surface by 0.39 m, but the increases were not evenly distributed along the study reach (Fig. 4). Bed aggradation and the resultant increase in the elevation of low-flow water surface were relatively large close to the check dam, attaining maximum values of around 1 m in cross-section 3, and decreased downstream to 0.2 and 0.12 m, respectively, in cross-section 10 (Fig. 4). As a result of this downstream decrease in the scale of bed aggradation, mean channel slope in the study reach increased from 0.0073 m m⁻¹ in 2013 to 0.0076 m m⁻¹ in 2015, i.e. by 4%. Importantly, the lack of block ramps on a relatively large distance in the middle part of the study reach prevented sediment retention and bed aggradation—in cross-section 6 located 300 m upstream of a block ramp, between 2013 and 2015 mean elevation of the channel bed increased only by 0.18 m and that of low-flow water surface by 0.05 m (Fig. 4).

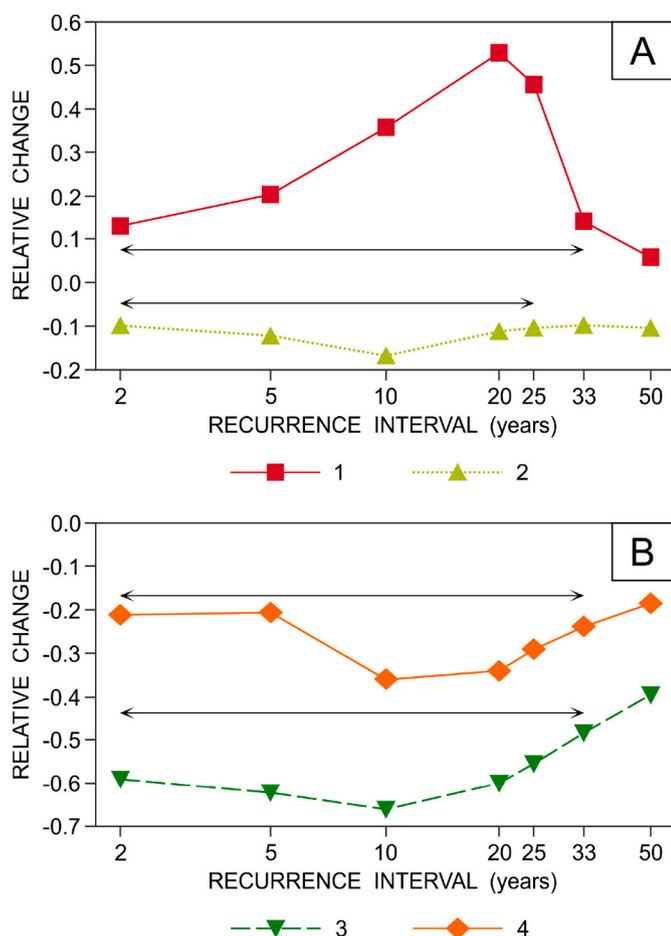
Fig. 5. Relative change in average values of hydraulic parameters characterizing geometry (A) and hydrodynamics (B) of flood flows of given recurrence intervals between 2013 and 2015. 1 – flow width; 2 – mean water depth; 3 – unit stream power; 4 – bed shear stress. Arrows indicate the extent of flood frequencies, for which the analysed changes in the hydraulic parameters were statistically significant.

Hydraulic modelling indicated that the reduction in flow capacity of the stream channel due to the sediment entrapment by block ramps exerted a marked influence on hydraulic parameters characterizing geometry of flood flows (Fig. 5A). The reduction increased the proportion of flood flows conveyed in the floodplain zone of the stream, which decreased mean water depth and increased the lateral extent of inundation at given flood discharges. The reduction in mean water depth increased from 10% at a 2-year flood to 17% at the flood of 10-year frequency and then decreased to about 10% at higher flood flows. The change in mean water depth was statistically significant for flood magnitudes up to a 25-year discharge (Fig. 5A). In turn, the increase in flow width ranged from 12.7% at the 2-year discharge to 52.6% at a 20-year flood and then its scale diminished to 6% at the flood of 50-year frequency. A statistically significant increase in flow width was recorded for flood magnitudes up to a 33-year discharge (Fig. 5A).

The described changes in geometry of flood flows were associated with marked changes in the values of parameters characterizing flow hydrodynamics (Fig. 5B). Unit stream power calculated for total cross-section decreased markedly between 2013 and 2015, and the reduction ranged from 59.1% at the 2-year flood to 66.1% at the discharge of 10-year frequency, and then its scale diminished with increasing flood magnitude to 39.6% at the 50-year flood. The reduction in unit stream power was statistically significant for flood magnitudes up to the 33-year discharge (Fig. 5B). In turn, the reduction in bed shear stress

calculated for total cross-section equalled ca. 21% at 2- and 5-year discharges, attained the maximum value of 36.1% at the 10-year flood, and with a further increase in flood magnitude its scale diminished to 18.6% at the flood of 50-year frequency. Similar to changes in unit stream power, a statistically significant reduction in bed shear stress was also recorded for flood magnitudes up to the 33-year discharge (Fig. 5B).

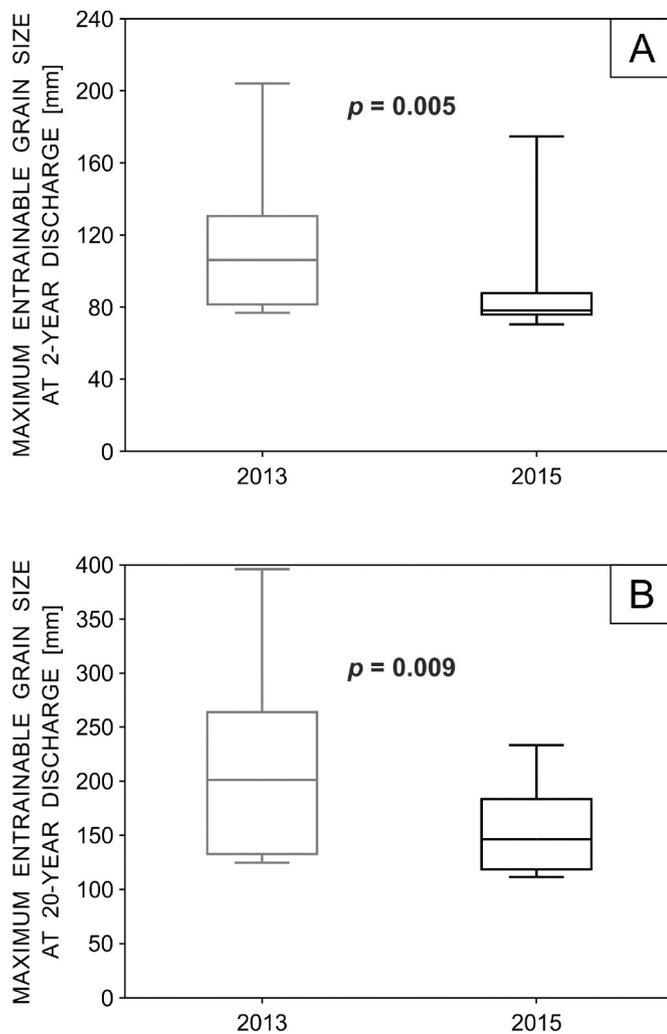
Fig. 6. Maximum size of bed material particles mobilized by 2-year (A) and 20-year flood discharges (B) in 10 study cross-sections of Krzczonówka Stream before (2013) and after (2015) the aggradation of channel bed by the sediment released from the lowered check dam. Boxplots show median (centre line), the first and the third quartiles (bottom and top of boxes) and extreme values (whiskers). Results of the Wilcoxon test for the significance of difference of the parameter between 2013 and 2015 are also indicated.

Average values of bed shear stress calculated for the flows conveyed in the channel zone of each cross-section were used to determine stream competence, i.e. the maximum size of bed material particles entrained by discharges of given frequency before and after the aggradation of the channel bed (cf. Gordon et al., 1992). In 2015 entrainable grain size was significantly lower than in 2013 for flood magnitudes up to the 33-year discharge and the pattern of the differences followed the differences in bed shear stress. We illustrate the effect of stream changes on entrainable grain size for 2-year and 20-year floods. While in 2013 the 2-year discharge could mobilize particles with the diameter varying between 77 and 204 mm in particular study cross-sections (115 mm on average), in 2015 it could entrain grains with the maximum diameter ranging from 70 to 175 mm in these cross-sections (mean = 94 mm); on average, entrainable grain size decreased by 18% (Fig. 6A). In 2013 the 20-year flood had a competence ranging from 125 to 396 mm in particular cross-

sections, whereas in 2015 stream competence varied between 111 and 233 mm, and this was reflected in the reduction of the average value of entrainable grain size for the 10 study cross-sections from 228 to 158 mm—a change by 31% (Fig. 6B).

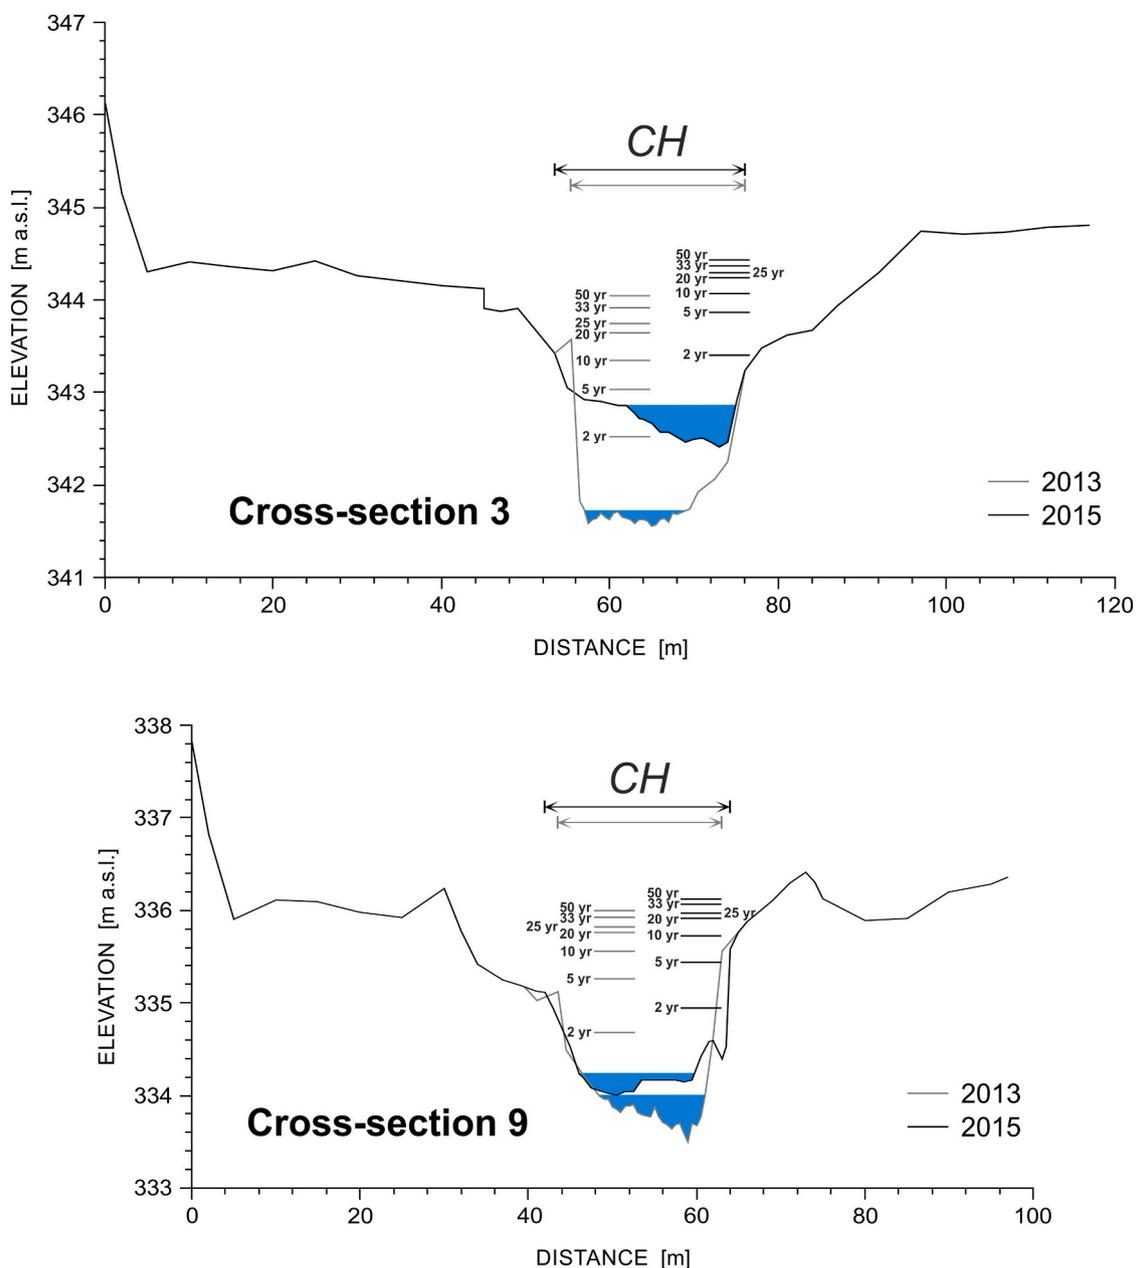
Fig. 7. Morphology of the Krzczonówka Stream channel in cross-sections 3 and 9 and the elevation of water stages associated with flood discharges of given recurrence intervals in 2013—before the installation of block ramps—and in 2015, after entrapment by the block ramps of the bed material flushed out from the lowered check dam. The cross-sections are located 470 m and 1530 m downstream from the check dam. Arrows indicate the extent of the stream channel.

Notwithstanding the lack of significance of the average change in the retention potential of the stream floodplain in the 10 study cross-sections, it is interesting to compare changes in the retention potential between cross-section 3, where the channel bed aggraded between 2013 and 2015 by 1.05 m, and cross-section 9 with the increase in bed elevation amounting to 0.37 m only (Fig. 7). In cross-section 3, before the restoration activities a very small proportion of the total flow was conveyed in the floodplain zone and noticeable floodplain inundation started at the 20-year flood (Fig. 7, Table 3). After the bed aggradation induced by the restoration activities, noticeable flow in the floodplain zone was already recorded at the flood of 5-year frequency (Fig. 7), and at higher flood magnitudes a proportion of the total flow conveyed over the floodplain increased by more than 10%. However, the proportion of flow area in the floodplain zone increased about twice more and this was reflected in a remarkable increase in the retention potential of the floodplain in this cross-section (Table 3). Moreover, prior to the restoration activities water started to be retained on the floodplain at the flow of 10-year frequency, while after the activities the onset of floodwater retention occurred already at the 2-year flood (Table 3).

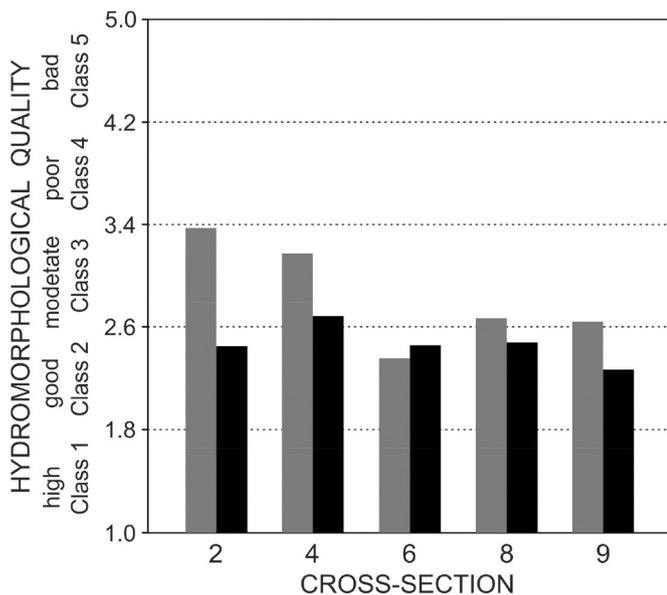
Fig. 8. Scores of hydromorphological quality of Krzczonówka Stream in the evaluated cross-sections given during the assessments in 2012, before the commencement of restoration activities (grey), and in 2015, after completing the activities (black).

The assessment performed in 2012, at the beginning of the restoration project, indicated that only one of the five evaluated cross-sections of Krzczonówka Stream represented good hydromorphological quality, whereas the remaining four cross-sections were classified as representing moderate quality (Fig. 8, Table S3). One of the assessed categories—in-river vegetation and organic debris—was considered to be in poor condition (Fig. 9) manifested in the lack of wooded islands and very scarce deposits of large wood in the incised channel. Average scores for six assessment categories indicated a moderate degree of modification of stream hydromorphology in these categories (Fig. 9). The evaluated cross-sections highly varied in longitudinal stream continuity (Fig. 9, Table S3) according to their distance to the check dam. A considerable disturbance to this continuity in the cross-sections located close to the check dam was reflected in their worst overall score (Fig. 8, Table S3).

The assessment performed in 2015, after the completion of all restoration activities in the stream, indicated improvement in the hydromorphological quality of four out of the five cross-sections. This improvement allowed three cross-sections to be upgraded from Class 3 to Class 2 of hydromorphological quality (Fig. 8, Table S4). The largest improvement—by 1 quality class on average—took place with respect to bed substrate (Fig. 9), reflecting the transformation of bedrock or bedrock–alluvial channel bed into a gravelly bed. Somewhat lesser but clearly apparent improvement was indicated with regard to the presence of erosional and depositional channel forms and longitudinal stream continuity; in both these categories, the largest improvement occurred in the cross-sections located close to the check dam, which reduced the variation in scores given to evaluated cross-sections (Fig. 9). Moreover, the presence of scarce wood deposits in the channel resulted in better evaluation of in-river vegetation and organic debris, which allowed for upgrading the stream in this assessment category from Class 4 to Class 3 (Fig. 9).

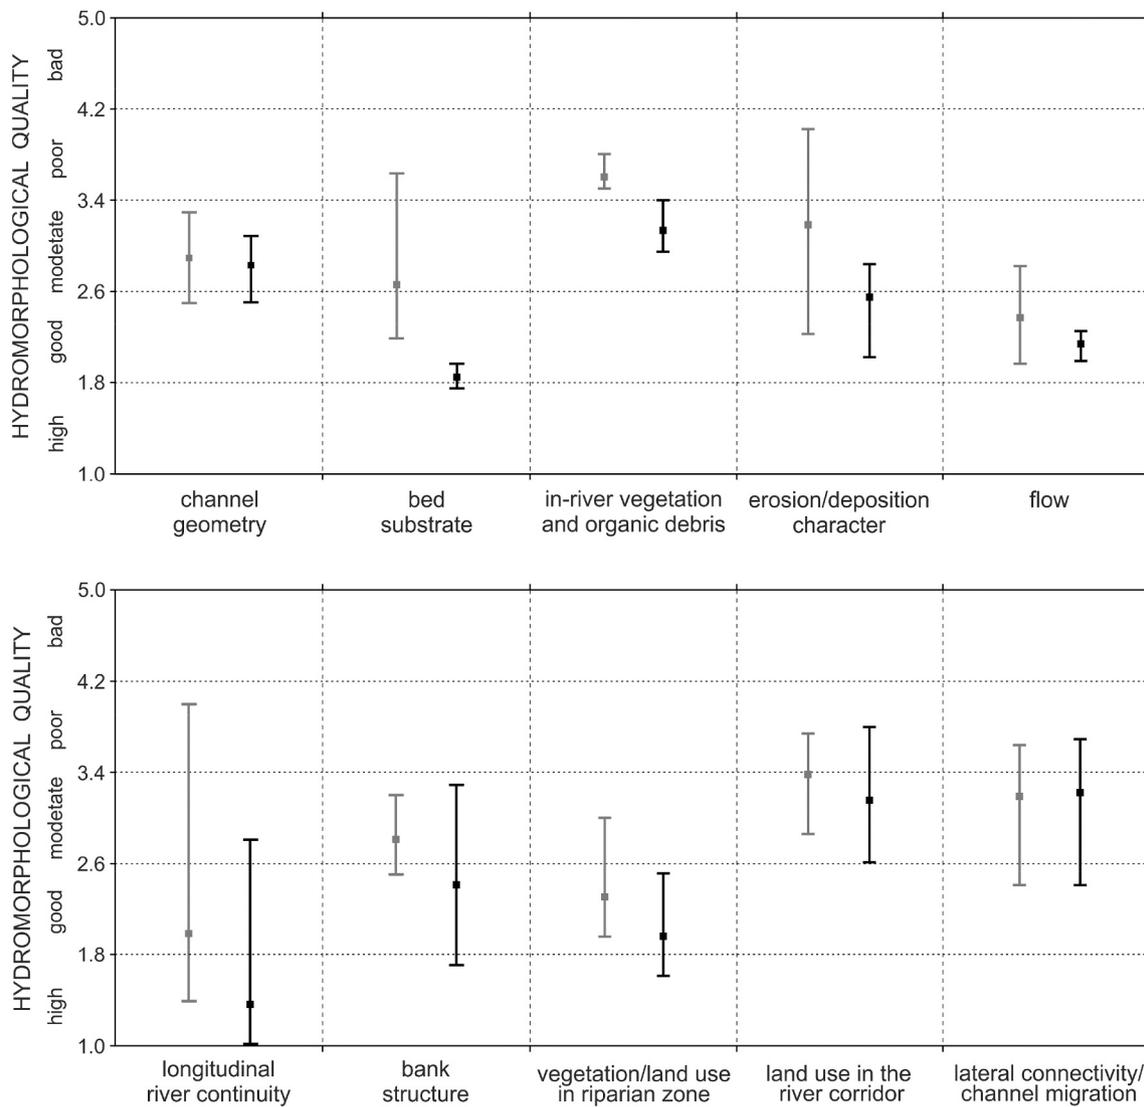
Fig. 9. Range and mean value of the average scores in particular assessment categories of hydromorphological quality given to evaluated cross-sections of Krzczonówka Stream in 2012, before the commencement of restoration activities (grey), and in 2015, after completing the activities (black).
